# Empire Solar Project

## Draft Water Body Site Investigation Report

April 27, 2012

H334844-0000-07-124-0274

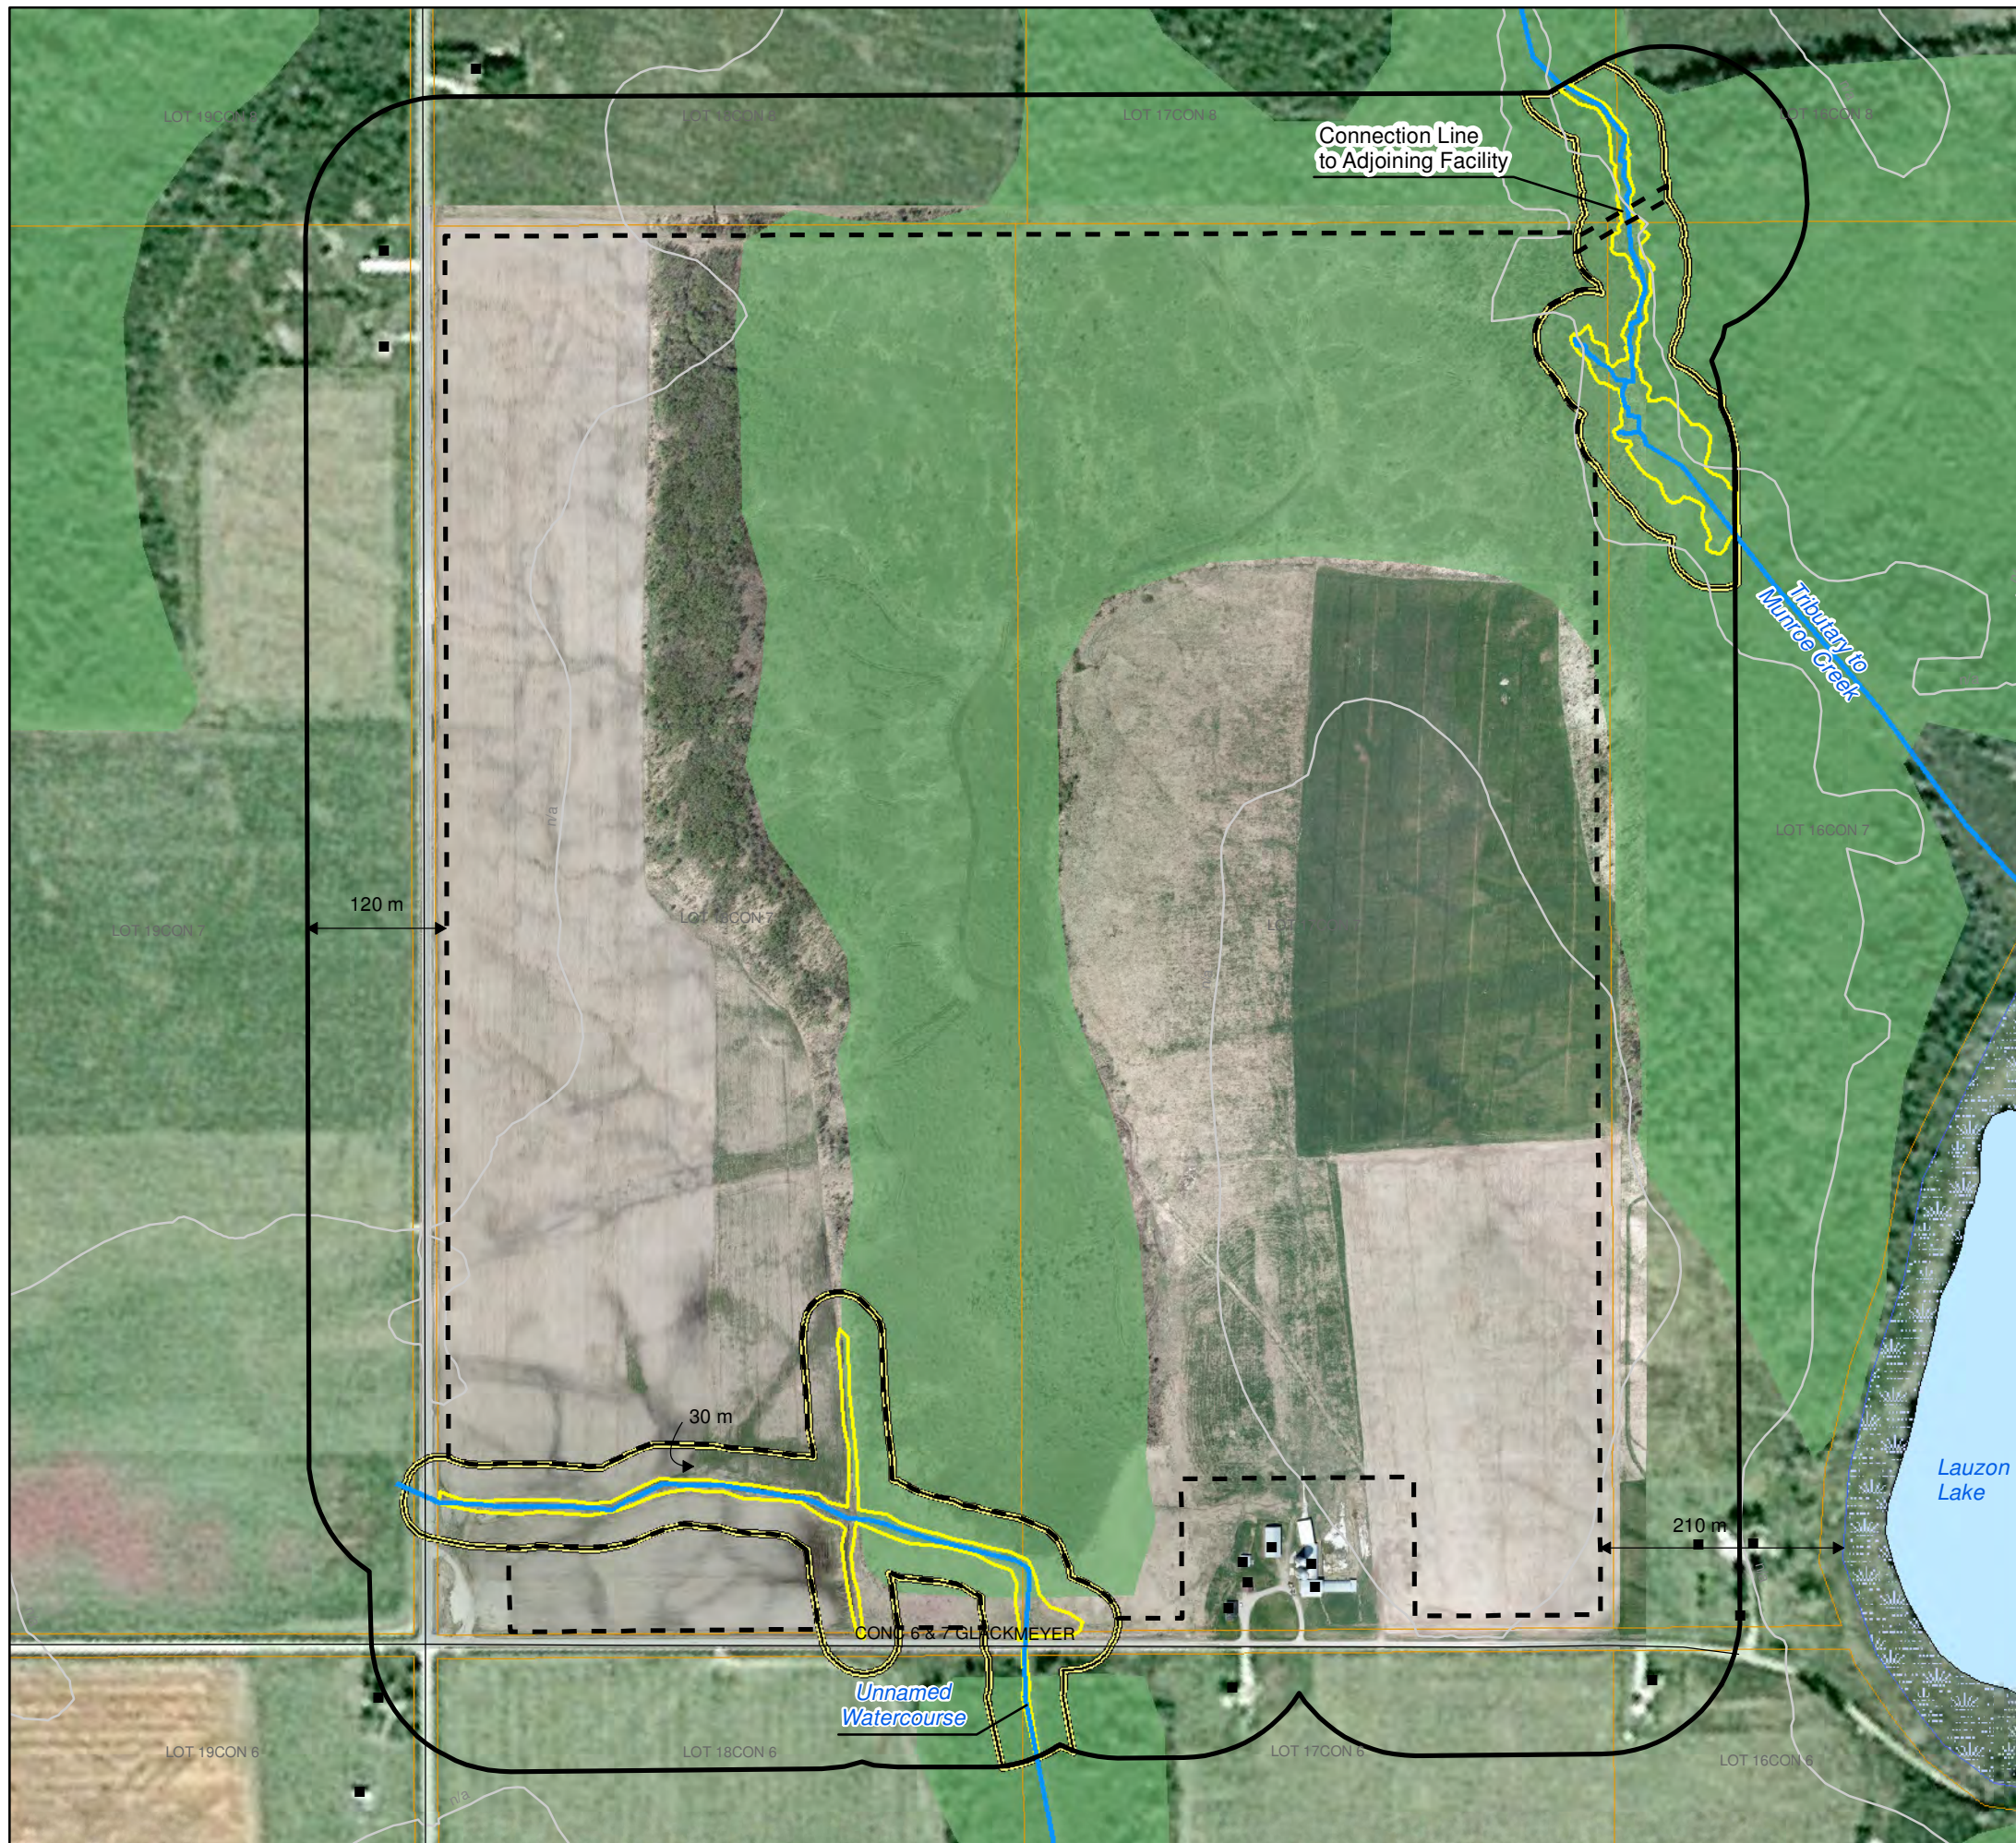
Figure 1.1  
 Northland Power Inc.  
**Empire Solar Project**  
**Water Body**  
**Site Investigation Results**

The average annual high water mark of the Unnamed Watercourse on the property was assessed during the site investigation and was found to be the top of banks of the channel for the western most portion of the watercourse and the limit of wet meadow vegetation adjacent to the channel area in the eastern portion of the watercourse. The surrounding vegetation is dominated by grasses, sedges and rushes which provide evidence of annual flooding during higher flow events. The average annual high water mark, associated 30-m setback limit and the proposed solar panel footprint boundary are shown in Figure 1.1. The proposed development footprint will be located between 30 and 120 m from the Unnamed Watercourse; therefore, an Environmental Impact Study (EIS) will be required.

Based on the results of the site investigation and the proposed Project components and boundaries shown in Figure 1.1, some components of the solar panel Project Location will be located between 30 and 120 m of the Unnamed Watercourse and the Tributary of Munroe Creek. In addition, the proposed distribution line Project location will cross or run within 120 m of approximately 38 waterbodies. Therefore, an EIS will be required to assess the potential effects of the Project and the required mitigation measures to prevent or minimize adverse effects on these waterbodies.

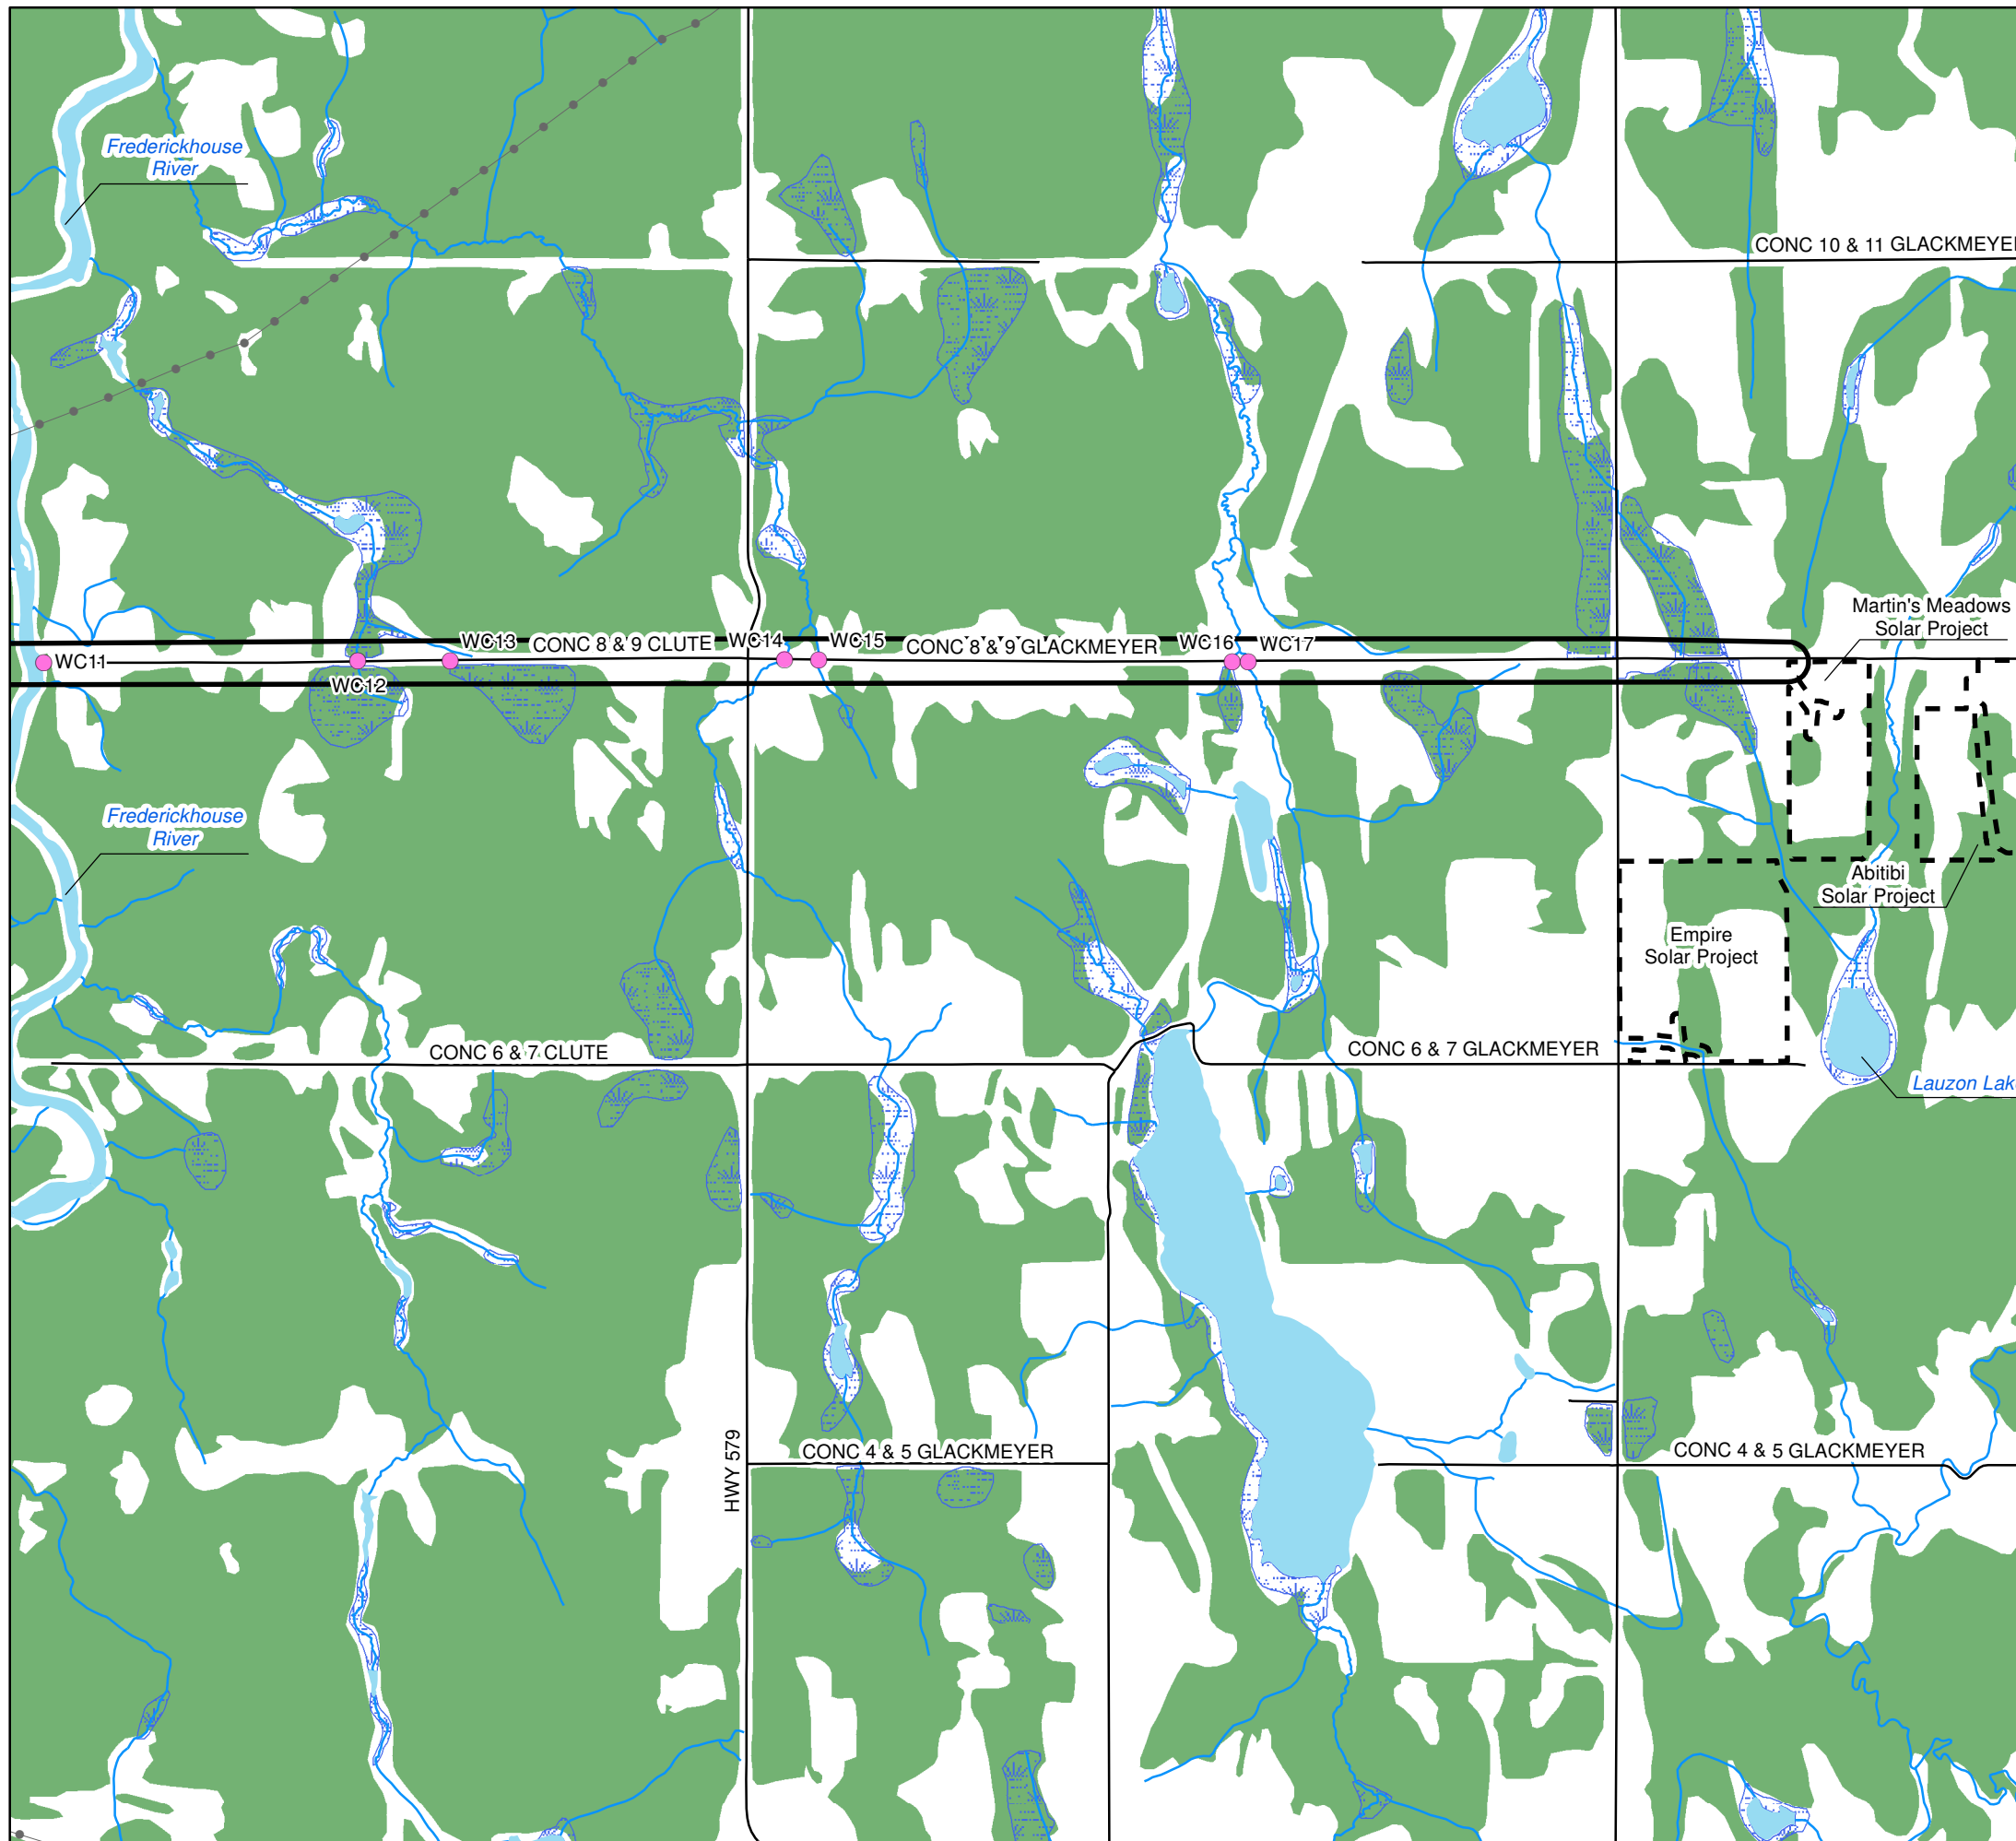
Figure 1.2  
 Northland Power Inc.  
**Distribution Line Project Location  
 (Eastern Half) - Waterbody  
 Site Investigation Results**

A total of 36 waterbodies were observed along the distribution line route options, as shown in Figures 1.2 and 1.3, and summarized in Table 4.1, which presents the watercourse identifier (as labelled in Figures 1.2 and 1.3), summary of watercourse observations (watercourse type, average width and depth, substrate, bank vegetation and other observations). There were 34 unnamed watercourses, the Frederickhouse River and Deception Creek. In addition, the proposed distribution line will pass within 120 m of Lower Deception Lake.

Since the Project Distribution line will cross or run within 120 m of the watercourses noted in Table 4.1, as well as one lake (Lower Deception Lake), an EIS will be required.

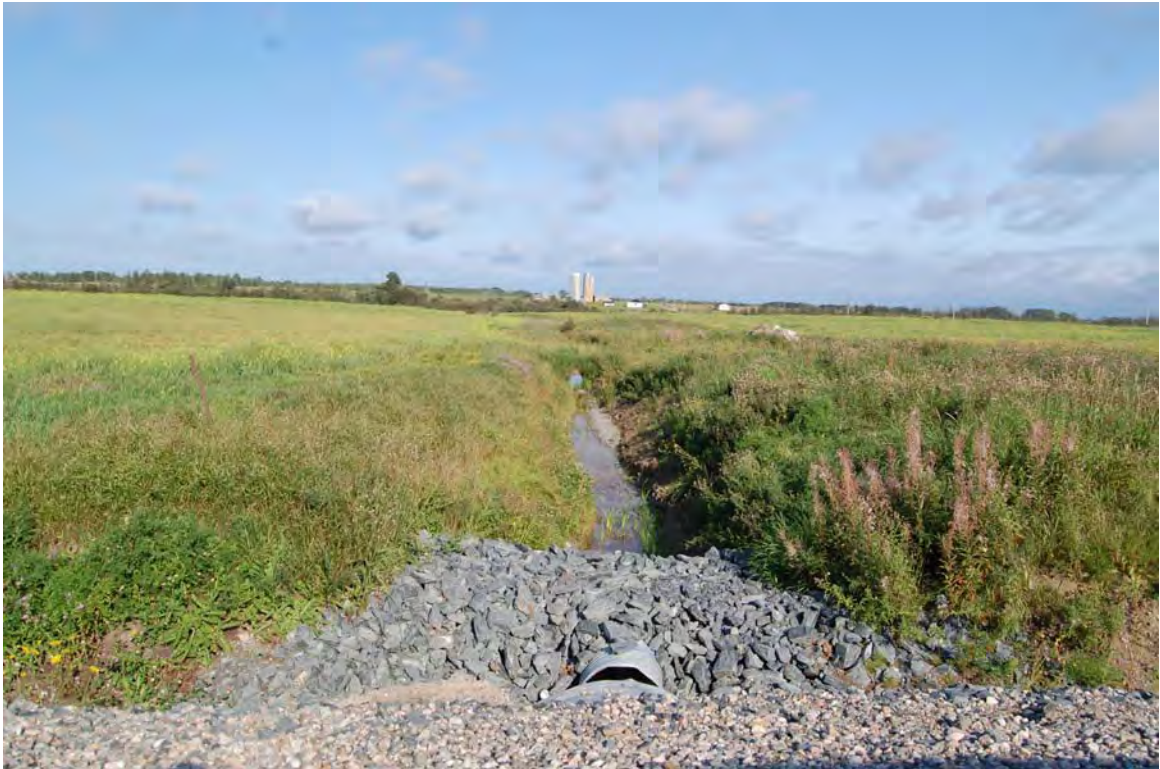
**Figure 4.1** View of Western Portion of Unnamed Watercourse Facing East from Western Property Line

The Land Information Ontario (LIO) mapping obtained for the *Water Body Records Review Report* (Hatch Ltd., 2012) indicated that the Unnamed Watercourse originates in the open field approximately 30 m west of the Project location and flows in an easterly direction through the property on which the Project is located. Along the western boundary of the property the watercourse is present as a defined channel, approximately 2 m wide. Little standing water was present within this portion of the watercourse during the August 2010 site investigation. A photograph of this portion of the watercourse is shown in Figure 4.1.

Continuing eastward the channel gradually becomes narrower reaching a minimum width of approximately 1 m. Standing water, vegetation and exposed bedrock was present within this portion of the watercourse. Depth of the channel remained fairly constant at approximately 1 m.

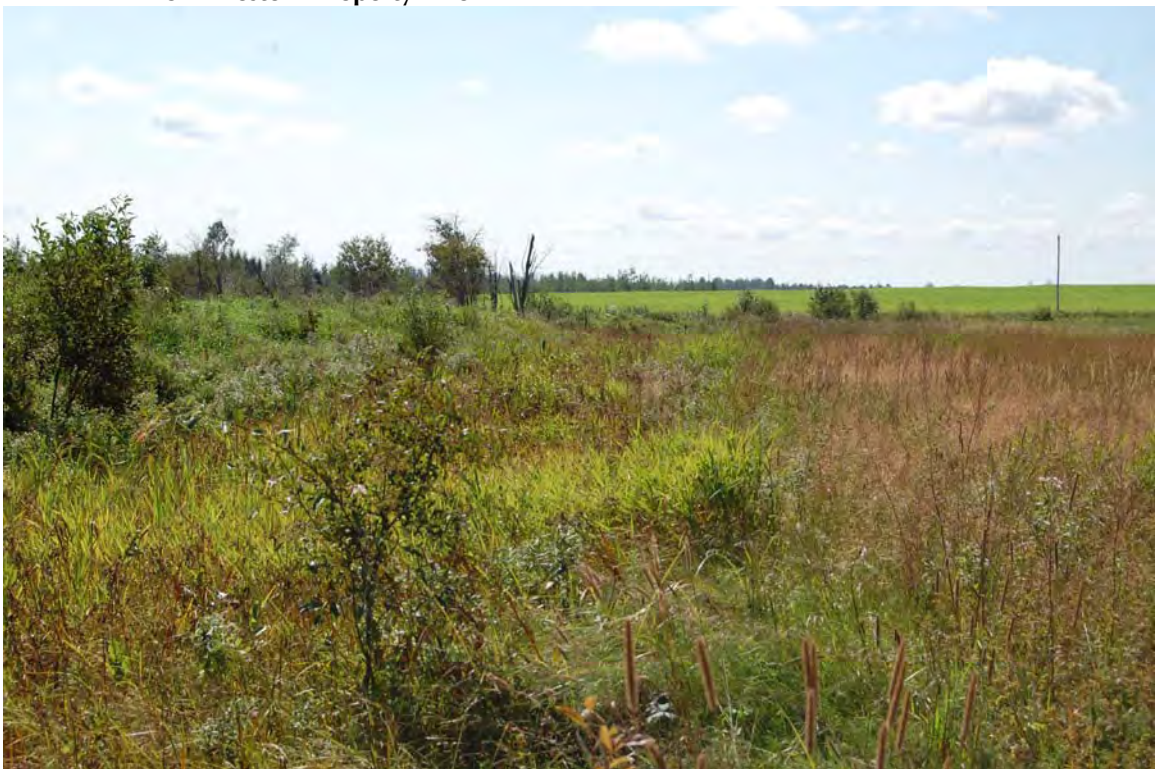
**Figure 4.2** View of Meadow Marsh Community on the Project Location

A tributary of the Unnamed Watercourse originates in the woodland in the centre of the Project Location. Once the watercourse reached the woodland in the middle of the project location it diffused out and the defined channel disappeared. This area was defined as a meadow marsh, a photo of which is provided in Figure 4.2.

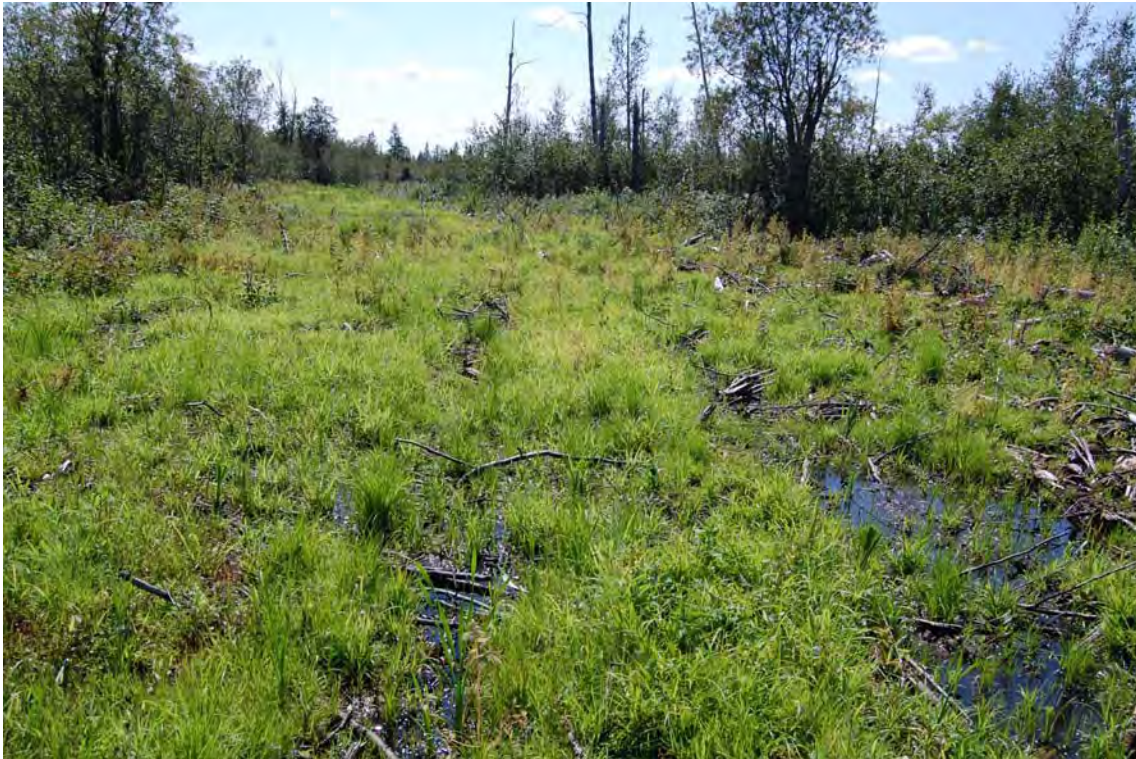
**Figure 4.3 View of Machinery Tracks Filled with Water Within the Woodland**

The woodland had at one point been cleared of all merchantable timber. Tracks left from the machinery cause pooling within the woodland. These features do not meet the definition of water body set out in the REA regulation. These tracks occurred throughout the woodland and were often covered in vegetation and downed vegetation and can be seen in Figure 4.3.
