# Empire Solar Project

## Draft Water Body Site Investigation Report

April 27, 2012

H334844-0000-07-124-0274

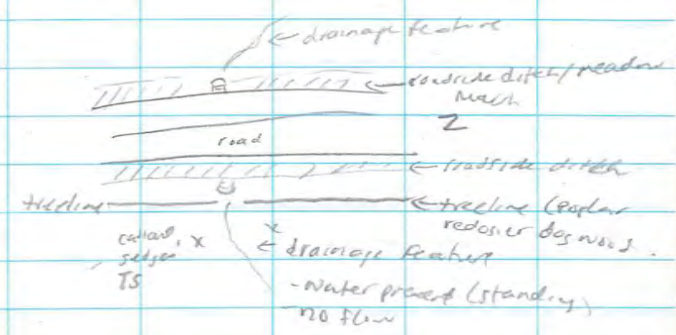
Drainage Feature / Wetland  
culvert under road - east & west

- west side - ~~no~~ defined bank, low-lying area / meadow-march - grasses, sedges, cattail

- East side

- drainage swale east into "meadow-march"  
- some pooled water present  
- no defined bank, TS swale into marsh (open muskeg)

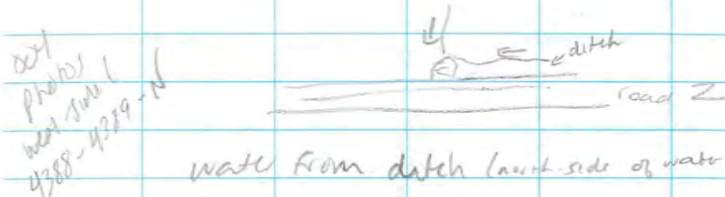
(4) west side 4390-4395

(4) Water Feature (Fower Creek?)

water from ditch (west side of water feature)  
flows south into water feature; water  
feature flows east

- water present - ~4" deep?
- channel width 1.5-2m
- shrubs, sedges & grasses along bank  
organic substrate

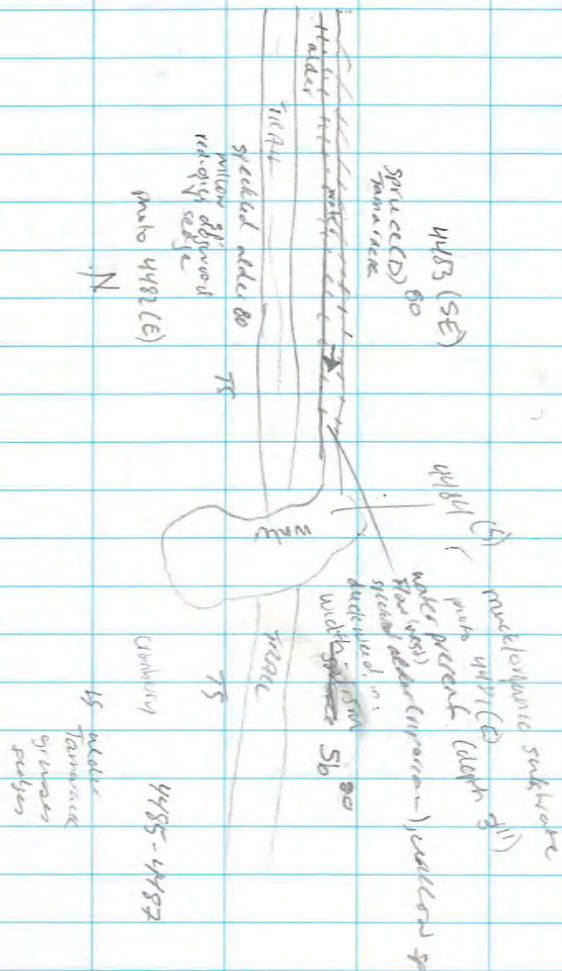
(16) Water Feature / Wetland  
- water present (permanent)
